Strength Test Report

Propeller Model ST68AAREI36

Liaoning General Aviation Research Institute

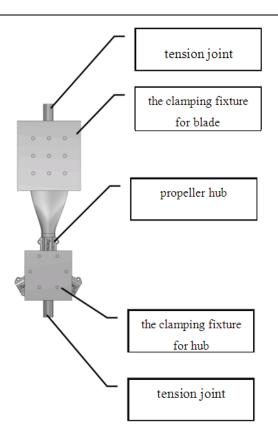
FIG. 2 Load method for the tested part

To fix the blade root and blade with the fixture as shown in FIG. 2, loading 50KN force to the fixture and maintain for 60min. The force is loading at the position of the corresponding center point and the load acted by the force onto the blade root and blade through the fixture, see FIG. 3. The fixture and loading toolings are made by Sterna and they must have enough rigidity.

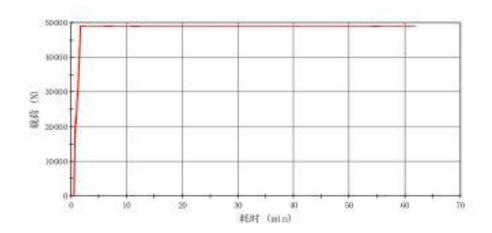
FIG. 4 Static test loading curve

The static test is carried out under 50KN load and maintain for 60min then unload, the loading curve displayed on the tensile testing machine is shown as in FIG. 4.

In the test, no damage or abnormal thing occurs in the blade root and the blade. After complete disassembling and inspections, no damage or cracks was found on the propeller. This proves the tested blade meets the requirements of strength and rigidity under the condition of 50KNload and maintain for 60min.

To analyze according to the test datas, the load value for the static test is within the error range allowed and the test datas are real and effective.
